Research Report  
301

**EVALUATION OF CORED SPECIMENS FROM  
TIMBER CAISSON BENEATH PIER NO. 2  
OF THE US 25 BRIDGE OVER  
THE OHIO RIVER BETWEEN COVINGTON AND  
CINCINNATI  
F141(1)**

Division of Research  
DEPARTMENT OF HIGHWAYS  
Commonwealth of Kentucky

December 1970

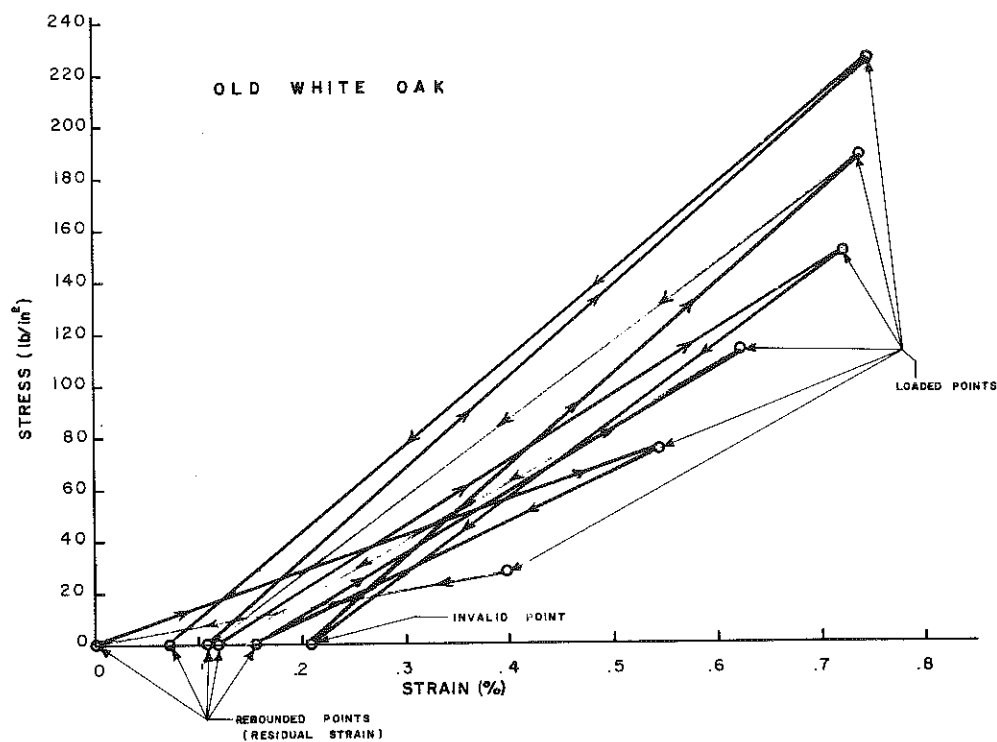
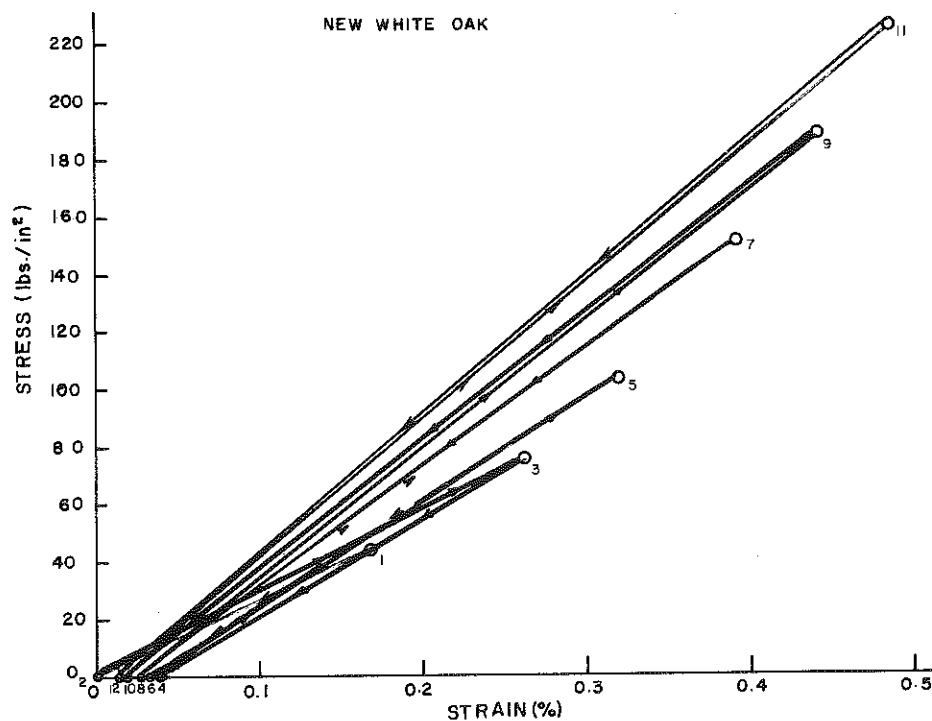
Comparative compression graphs obtained from similar tests on a specimen of new white oak are provided for each of the test situations. Significant differences between the old wood and new wood are:

1. The old wood was kept wet except for slight drying while shaping the specimens; the new wood specimens were shaped and then soaked for five days.
2. The specimen of old wood contained 19 rings and 13 rays per inch; the new wood specimen contained 9 rings and 9 rays per inch.

Fig. 6: Strain-Hysteresis Tests: Old and New Wood. Arrows show cycling of loads; points show total strains with respect to original height of specimen. Residual strain points show the unrecovered strains from each load-rebound cycle.

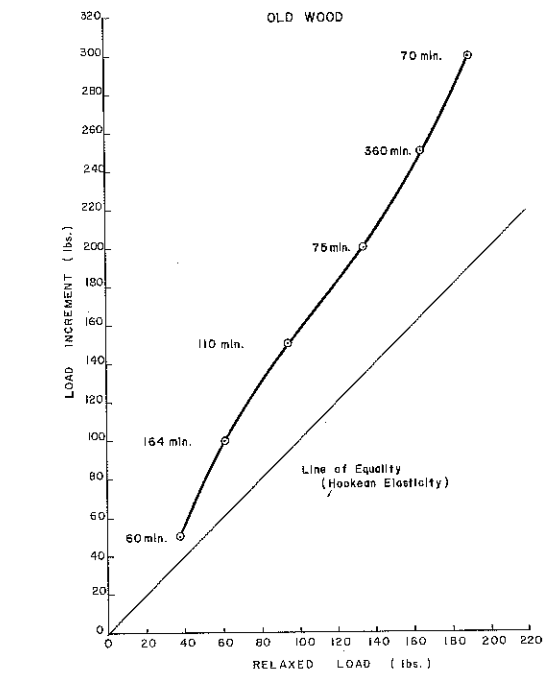
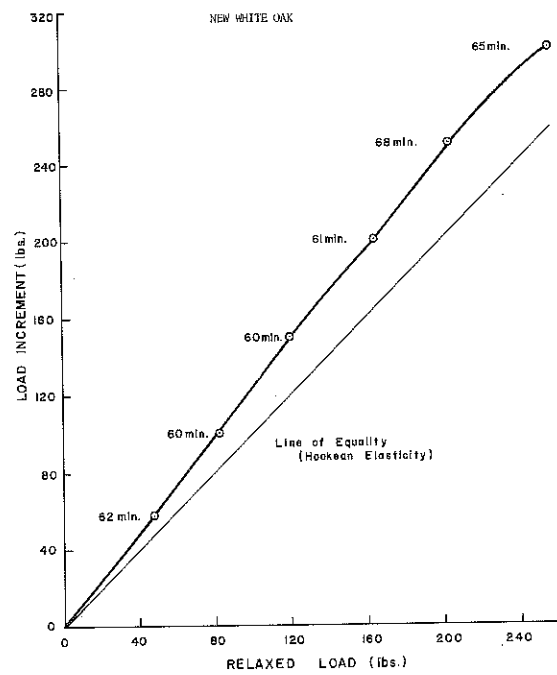
Fig. 7: Relaxation or Subsidence of Load - Due to Creep.

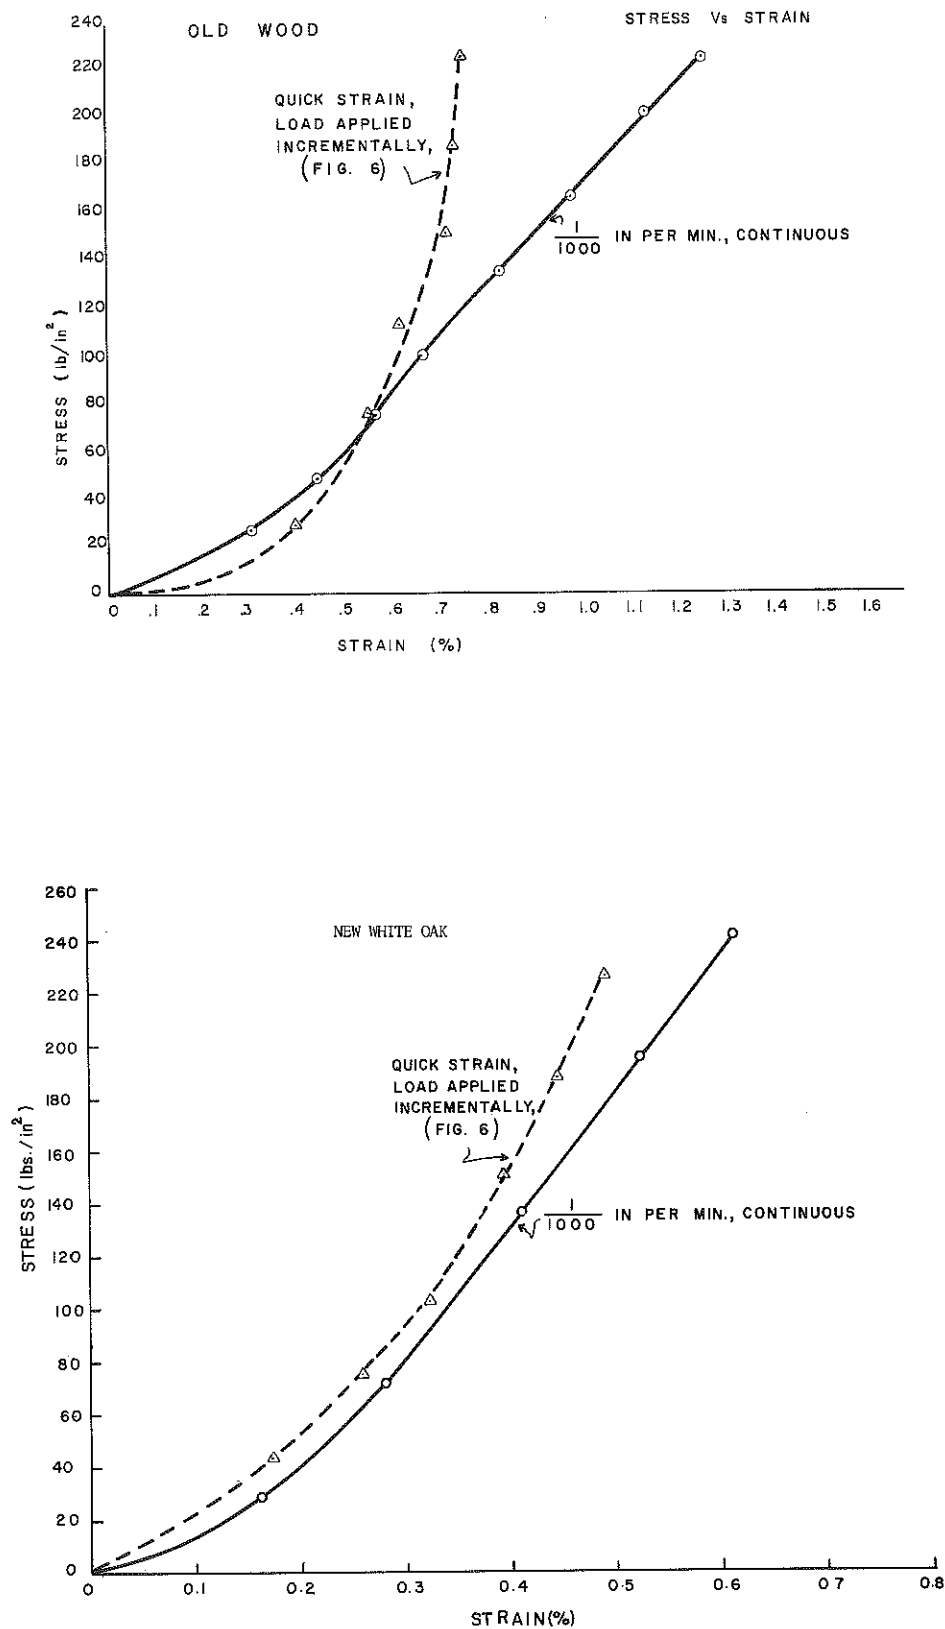
Finally, after a period of rest, the specimen was loaded at a constant rate of strain (1/1000 in. per min.) while monitoring the load. The resulting stress-strain graph is shown in Fig. 8. The effects of the previous strain history of the specimen is evident in the lower portion of the curve; some collapse of internal fibers undoubtedly occurred during previous loadings;

thereafter near-linearity is resumed. Also shown there is stress-strain curve obtained from successive, quick applications of 50-lb. increments of load (from Fig. 6 ).

Fig. 8: Stress-Strain Curves Obtained in Triaxial Test Apparatus (20 psi lateral pressure) Following Creep-Relaxation Tests.

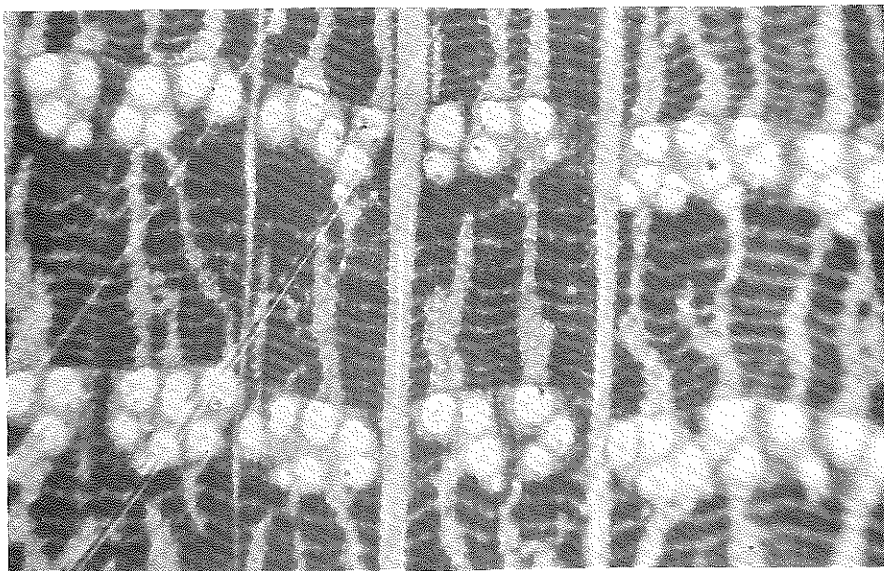
The inner structure of white oak wood is similar to that of red oak, but white oak has perceptibly more abundant tyloses filling large spring-growth tracheid. Fig. 9 is a cross-sectional view of new wood (magnified 13.5 times). The parts are labeled. It is reportedly possible to blow air through the pores of a short length of red oak whereas the pores in white oak are plugged with tyloses. Tyloses are an intrusive growth of parenchyma cells into tracheid cells after sap flow subsides. Tracheid comprise the principal vertical (axial) piping system; they feed smaller, horizontal (radial) tracheid. These occur principally in the rays. The rays are discontinuous in the vertical direction and are an inch or more in height in white oak.

Fig. 9: Cross-Sectional View of New White Oak Magnified 13.5X.

1. Annual rings are large vertical pores (tracheid) produced by early spring growth; as growing season progresses additional pores form but become successively smaller and farther apart. The late wood growth is more dense and is stronger.
2. Radial rays are horizontal cells and lateral conductors of sap; they act as a lateral (radial) piping system. Rays are discontinuous in the vertical direction; each bundle is about one inch in height.

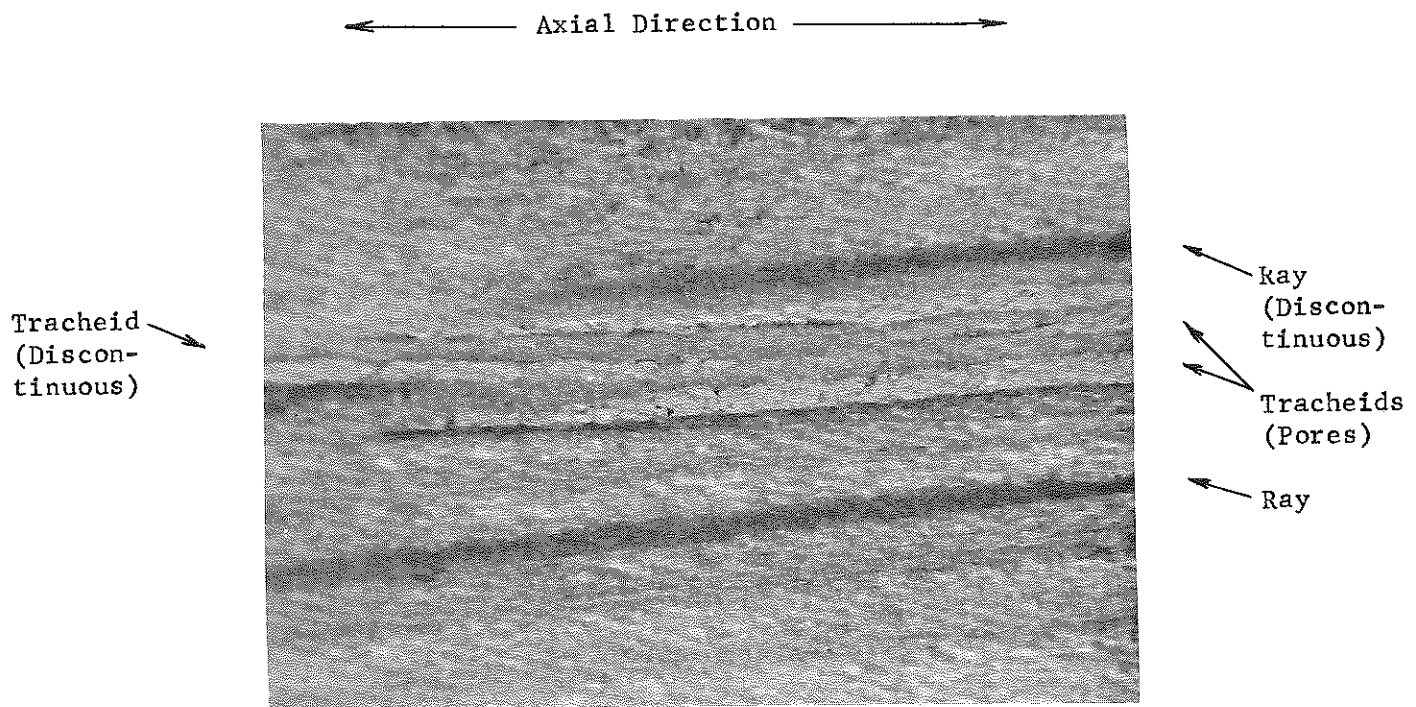
Fig. 10 is a companion to Fig. 9 and shows a side view of the same specimen.

Fig. 10: Side View of New White Oak, Magnified 13.5X.

1. Tracheids, (Pores) filled with tyloses.
2. Ray; radial pores are not visible at this magnification.

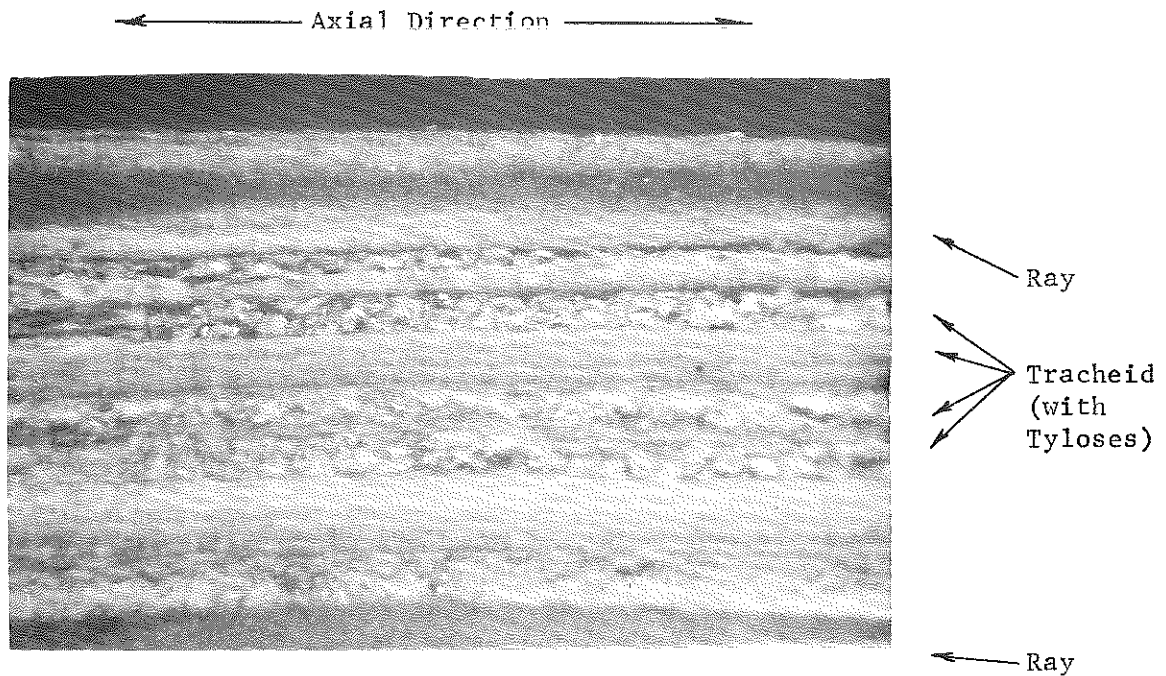
Fig. 13 is bright wood from Pier No. 2 and is comparative to Fig. 12.

Fig. 13: Side View of Bright Wood from Pier No. 2, Magnified 17.5X.

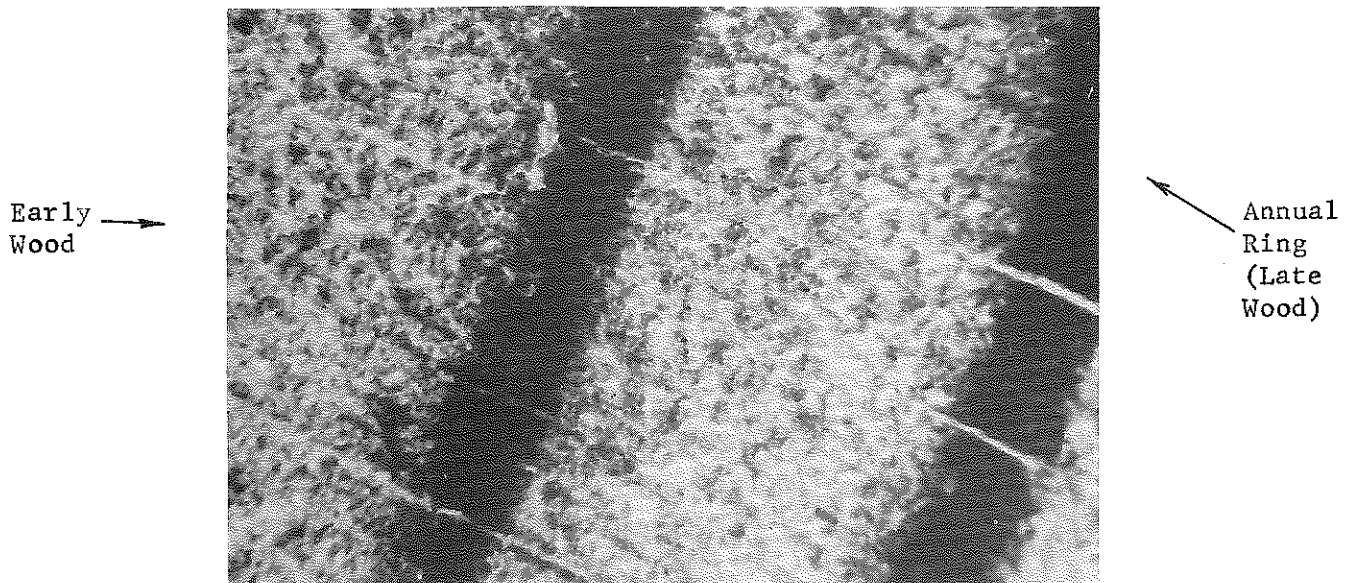
Fig. 14 illustrates the pine in cross-section.

Fig. 14: Cross-Sectional View of Pine from Pier No. 2, Magnified 17.5X. In contrast to hardwoods, strength of conifer woods increases as the number of rings per inch increases.

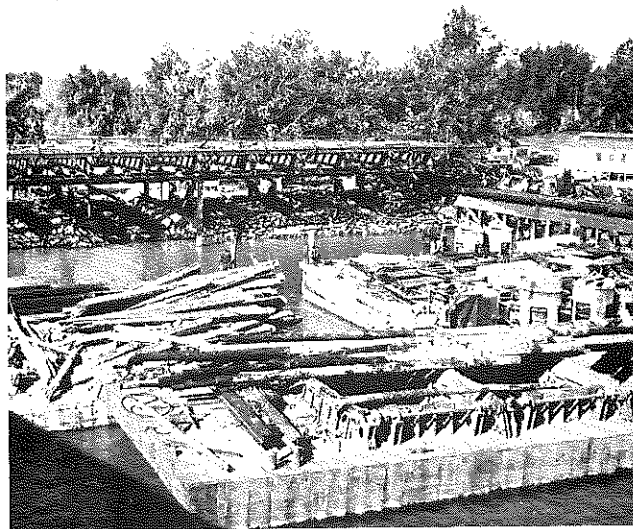
When the old bridge was dismantled, after nearly 60 years of service, piling and piers were found to be insufficiently sound for the construction of a new bridge. Pilings were sent to the Forest Products Laboratory at Madison, Wisconsin for detailed study. This examination revealed that even though these piles had been in fresh water, the timbers above the mudline had less than one-half their original strength, and below mudline they had no more than about 80% of their original strength.

The pilings that are on the barge are a few that were pulled when the 14th Street Bridge was razed.

This FPL report is presented to show the results of the examination by the Forest Products Laboratory. The many aspects of this report are worthy of further analysis and consideration by specifiers and users of timber products. It seems prudent to avoid possible material deterioration in fresh water installations by specifying the use of pressure-treated timber piles. — **WOOD PRESERVING**

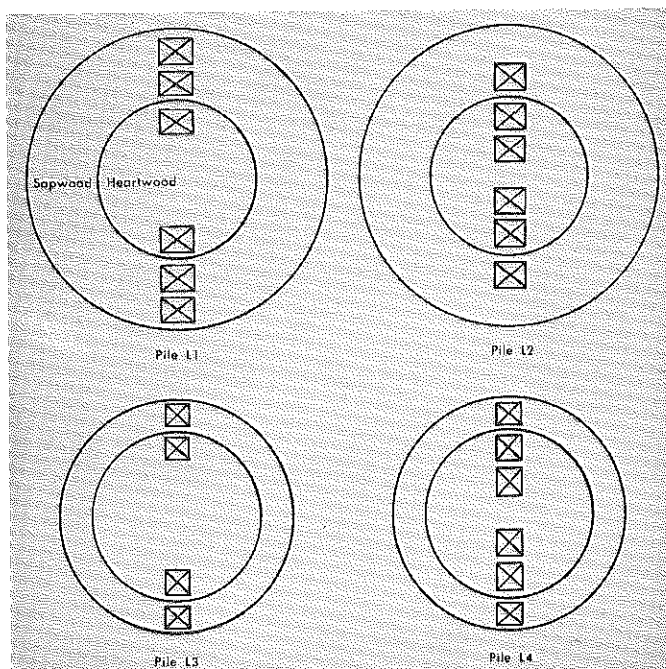
The sections were tested for strength in compression parallel to the grain. Specimens were 1 by 1 by 4 inches and they were tested in the green condition in accordance with the procedure outlined in ASTM D143. The location of the specimens is shown in Figure 1. The results are shown in Table 1.

Diagram for cutting 1" by 1" compression parallel to grain specimens from pile sections obtained from pier 9 of the 14th Street Bridge, Washington, D.C.
